EXPOSED LAMINATE BALUSTRADE INSTALLATION RECOMMENDATIONS

Exposed laminate balustrade installation recommendations

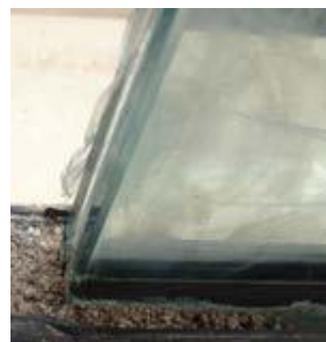
If any laminate product is glazed in such a way that water is allowed to pool around the interlayer for extended periods, the moisture will eventually leach into the interlayer which will then lose adhesion and could delaminate. This is typically seen initially as edge blush, a gradual white misty ingress from the source of moisture which seeps into the panel.

Typical moisture ingress of interlayer
